# Manhole Inspection Summary

Manhole # S31CC\_008MH

Insp Date: **2/7/07 8:26 AM**

**Location** Address: **201 PRESTON ST**

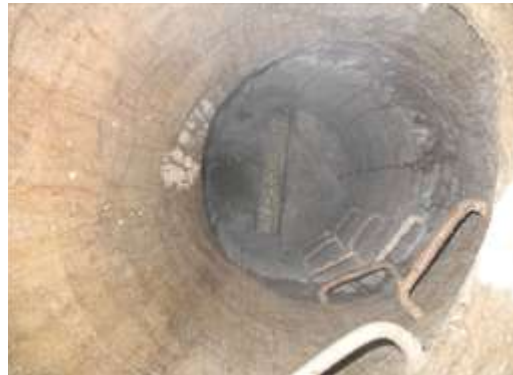
Top View

Corroded steps. Bench debris.

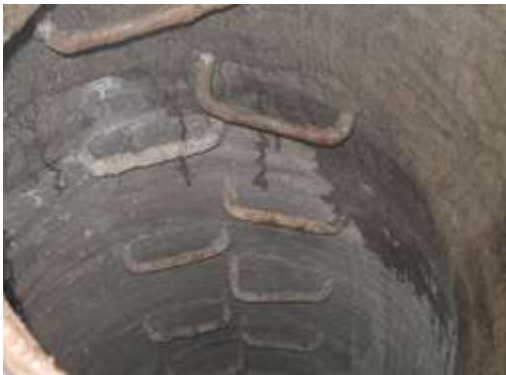
Defect

Adjustment and Corbel infiltration.

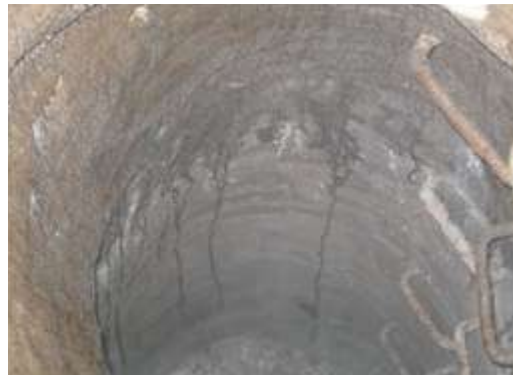
Defect

Frame leaks. Adjustment infiltration - other side.

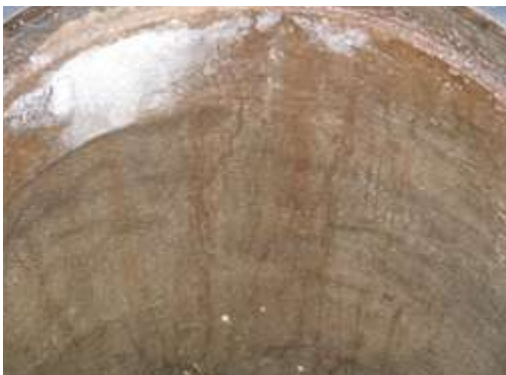
Defect

Frame leaks. Adjustment infiltration.

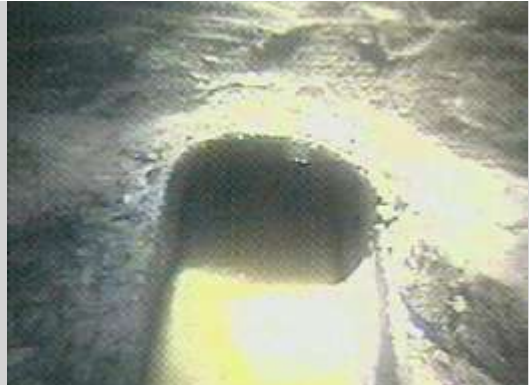
### 8 in. Circular Gravity Sewer Pipe Out @ 12 O'Clock

Pipe Material: **Unknown** ☒ Pipe Lined

Invert Depth: **16.50** (ft.) Flow Characteristics: **Fast**

Infiltration: **None** Pipe Seal Cond: **Unknown**

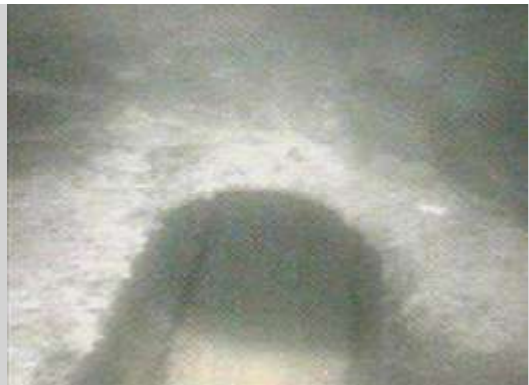
### 8 in. Circular Gravity Sewer Pipe In @ 6 O'Clock

Pipe Material: **Unknown** ☒ Pipe Lined

Invert Depth: **16.42** (ft.) Flow Characteristics: **Fast**

Infiltration: **None** Pipe Seal Cond: **Unknown**
